Adaptive Reuse of Abandoned Churches in the Walled City of Famagusta, North Cyprus

JOURNAL OF MEDITERRANEAN CITIES (2024), 4(1), 130-155
https://doi.org/10.38027/mediterranean-cities_vol4no1_8

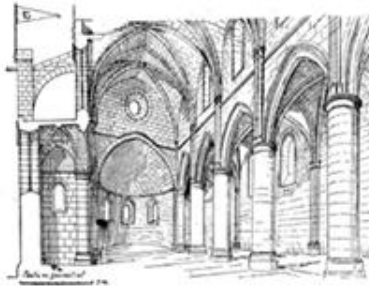
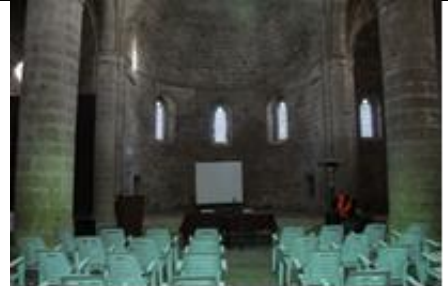
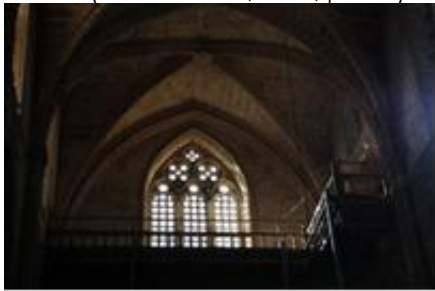
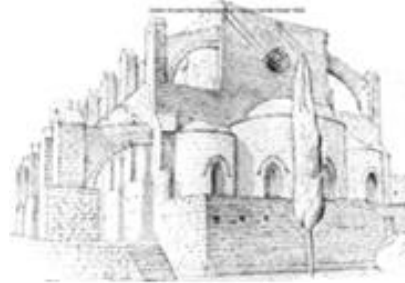
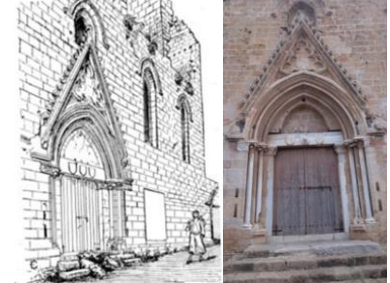
A. SS Peter & Paul Church, Sinan Pasha Mosque, Buğday Mosque (Babazadeh-Asbagh, 2023b, p. 170).

Plan (Enlart & Hunt, 1987, p. 247)

Section (Enlart & Hunt, 1987, p. 247)

Interior (Author's Compilation, 2019)

South-East View (Enlart & Hunt, 1987, pp. 578-579)

North Façade (Left: Enlart & Hunt, 1987, p. 250; Right: Author's Compilation, 2019)

SS Peter & Paul Church has a good structural system, good external and internal structures, a good upper structure, and good ornamental elements (See Table 4) with an internal area of approximately 407 square metres (See Figure 1A & Table 3). It was a Latin church passed on to the Syrians in a later period. It was used as a granary, store, stable, and storage of potatoes sometimes. It was supposed to be converted into a museum. It was used as a cultural centre and wedding ceremony hall in the 1960s. It was used as a library in 1974. It was used as a mosque in the 1990s (See Table 5). Currently, it is closed almost all the time and open for a few events of EMU. It can be reused as an interpretation centre or tourist information centre opened every day for informing and guiding international tourists, students, and even the locals as it is needed in the Walled City of Famagusta (Babazadeh-Asbagh, 2023b, p. 83) (See Figure 1A).

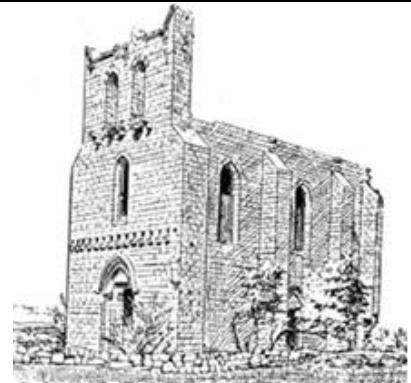
B. St Anne Church, S. Anna Church, Maronite Church (Babazadeh-Asbagh, 2023b, p. 194).

Plan (Enlart & Hunt, 1987, p. 278)

Section (Enlart & Hunt, 1987, p. 275)

South-West View (Enlart & Hunt, 1987, p. 277)

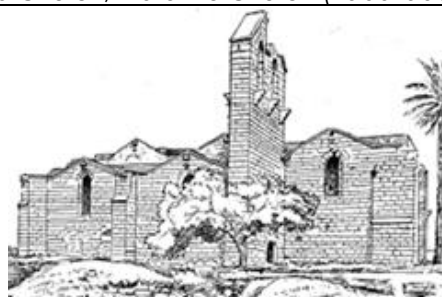
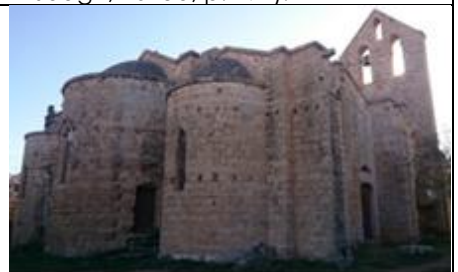
C. The Nestorian Church, Ayios Yeorghios Xorinos Church, Church of Agios Georgios Exorinos, St George the Exiler Church (Babazadeh-Asbagh, 2023b, p. 198).

Plan (Enlart & Hunt, 1987, p. 281)

North Façade (Enlart & Hunt, 1987, p. 282)

North-East Façade (Author's Compilation, 2019)

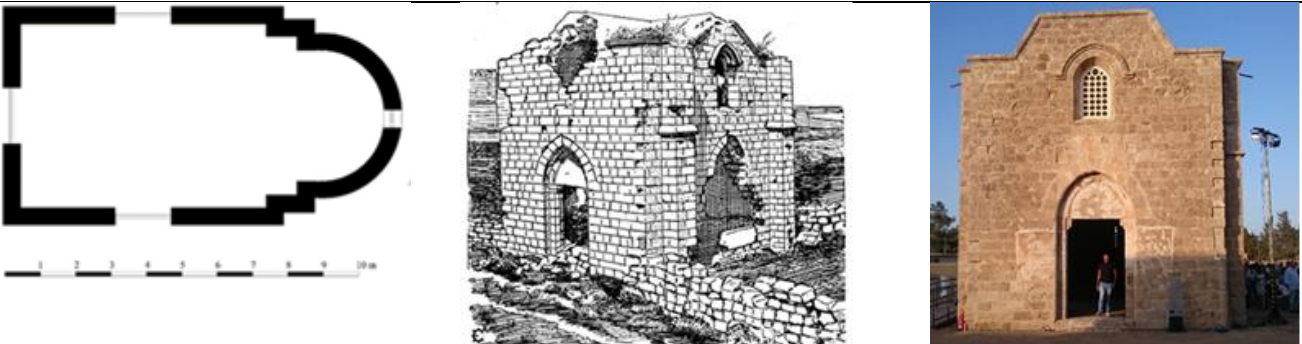
D. St Mary of Armenian Church, Saint Marie Church, St Mary's of the Armenians, Tabakhane (Tannery) (Babazadeh-Asbagh, 2023b, p. 202).

Plan (Author's Compilation, 2019)

South-West View (Enlart & Hunt, 1987, p. 286)

West Façade (Author's Compilation, 2019)

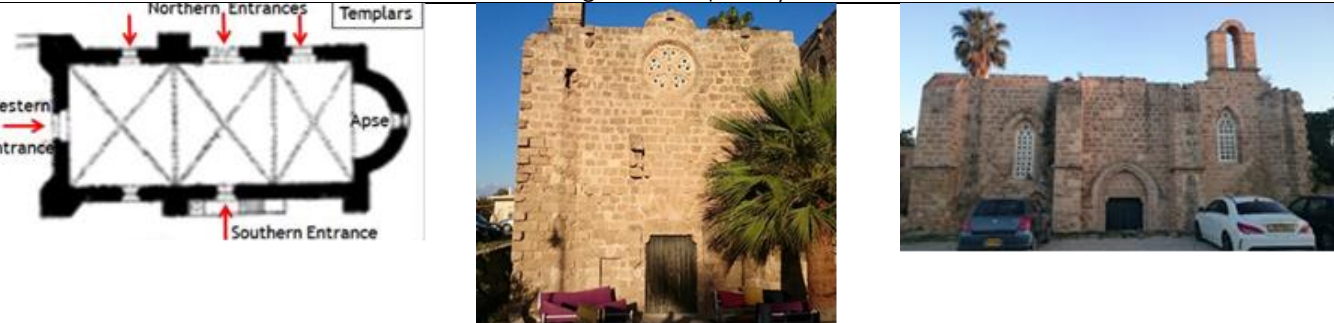
E. Templars' Church, one of the Twin Churches (Babazadeh-Asbagh, 2023b, p. 206).

Plan (Enlart & Hunt, 1987, p. 291)

West Façade (Author's Compilation, 2019)

North Façade (Author's Compilation, 2019)

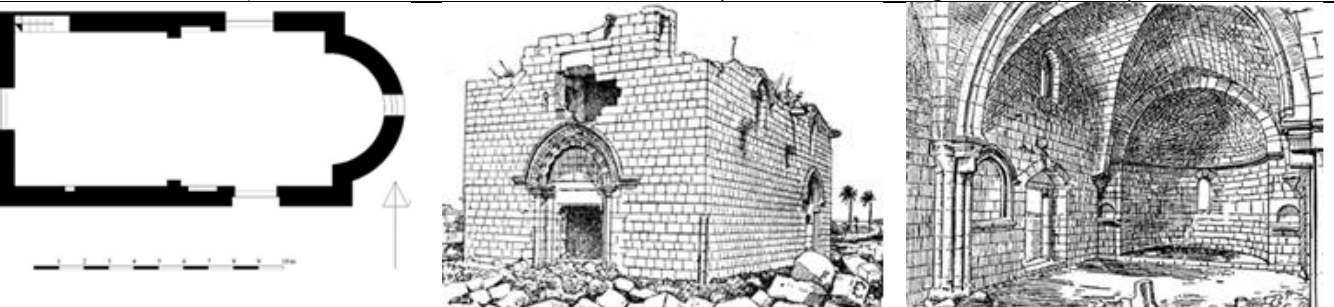
F. Jacobean Church, Tabakhane Mosque, Tanners' Mosque, Jacobite Church (Babazadeh-Asbagh, 2023b, p. 214).

Plan (Author's Compilation, 2019)

South-West View (Enlart & Hunt, 1987, p. 299)

Interior (Enlart & Hunt, 1987, p. 301)

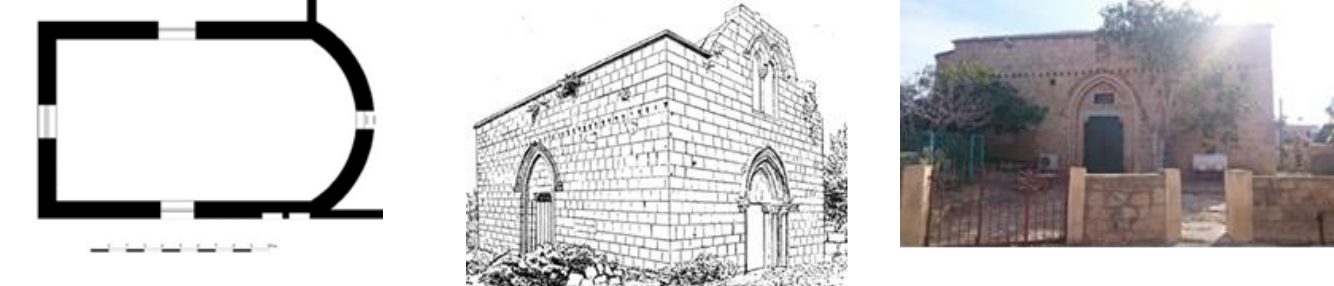
G. Mustafa Pasha Mosque, Stavros Church (Babazadeh-Asbagh, 2023b, p. 218).

Plan (Author's Compilation, 2019)

North-West View (Enlart & Hunt, 1987, p. 302)

North Façade (Author's Compilation, 2019)
